I-35W Mississippi river bridge failure – Is it a wake up call?

N. Subramanian

The I-35W Mississippi river bridge

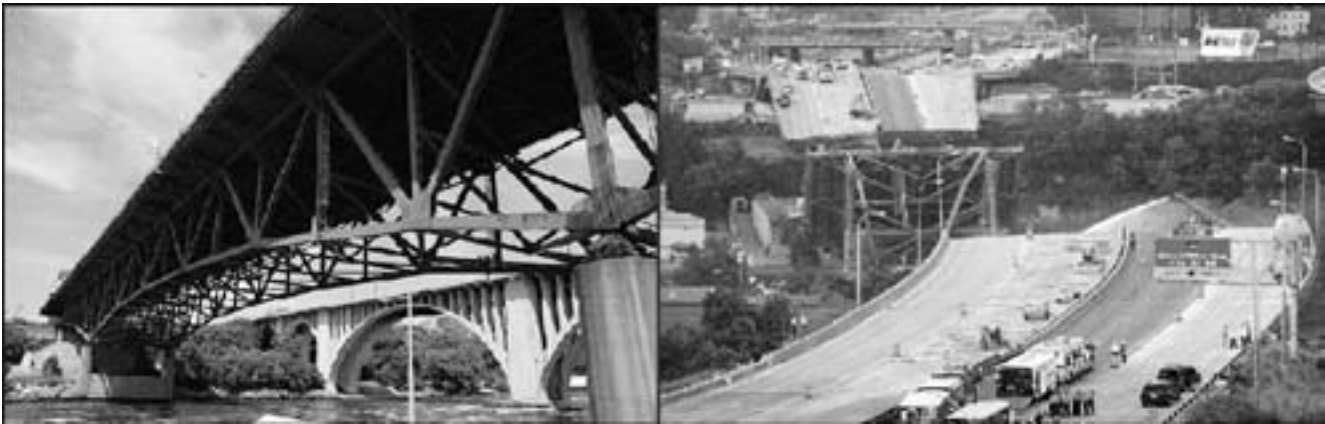
Figure 1. The I-35W Mississippi river bridge - Before and after failure

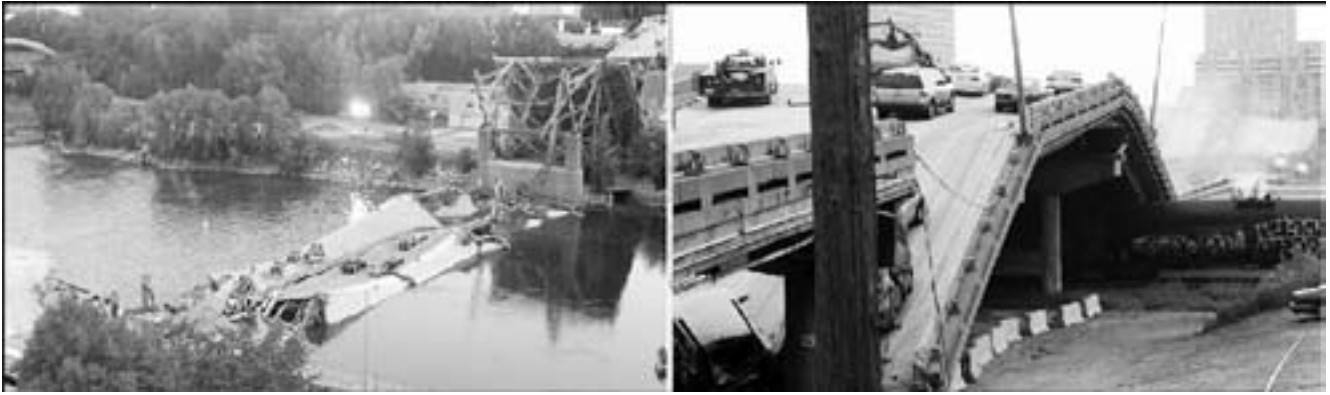
Figure 2. Two different views of the I-35W bridge failure

During the weekday evening rush hour on August 1, 2007, with the bridge traffic moving slowly through the limited number of lanes, the central span of the bridge suddenly gave way followed by the adjoining spans. The structure and deck collapsed into the river and onto the river banks below, the south part toppling 25 m eastward in the process. Approximately 100 vehicles were involved, sending their occupants and several construction workers up to 35 m down to the river or onto its banks, Figure 2. Northern sections fell onto three unoccupied and stationary freight train cars sitting in the rail yard in that sector. Thirteen people died and over 100 people were injured because of this incident.

NTSB which investigated the bridge failure has recently concluded that the gusset plates which connected the steel beams of the bridge were roughly half the thickness than they should have been and hence contributed to the failure of the bridge. NTSB investigators found 16 fractured gusset plates from the bridge's centre span. Their investigation found no evidence that cracking, corrosion or other wear 'played any role in the collapse of the bridge.' They also found no flaws in the steel and concrete material used in the bridge.

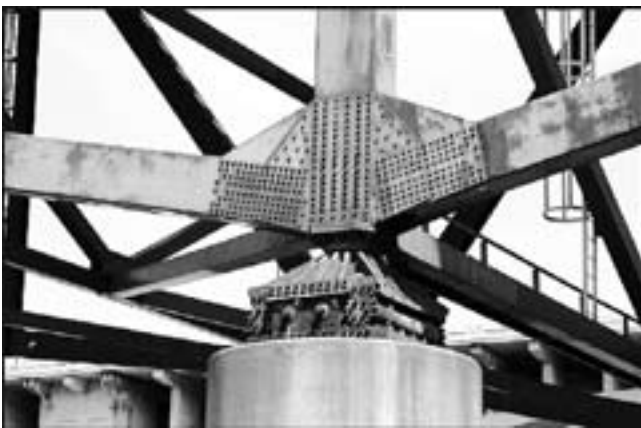
In 1990, the federal government gave the I-35W bridge a rating of 'structurally deficient', citing significant corrosion in its bearings. "Structurally deficient" is a classification term, which does not in itself indicate a lack of safety; over 75,000 other U.S. bridges have this classification! Seven years later, significant out-of-plane distortion was noted in the main trusses connected to cross girders due to resistance to motion at the connection cross bearings, according to a report released by the University of Minnesota civil engineering department. The cracks in the girders were drilled to prevent further propagation. Support struts were also added to the cross girder.

Figure 3. Corrosion of members and bearings of the I-35W bridge

The area of the bridge's south abutment was a site of industrial chemical pollution. Hence, there was also corrosion of members especially at the bearings (Figure 3). In fact, 13,600 tonne of contaminated soil were removed from below the bridge, ground up with wood chips and burned as a fuel additive for a power plant between 1993 and 1998 at a cost of US \$30 million.

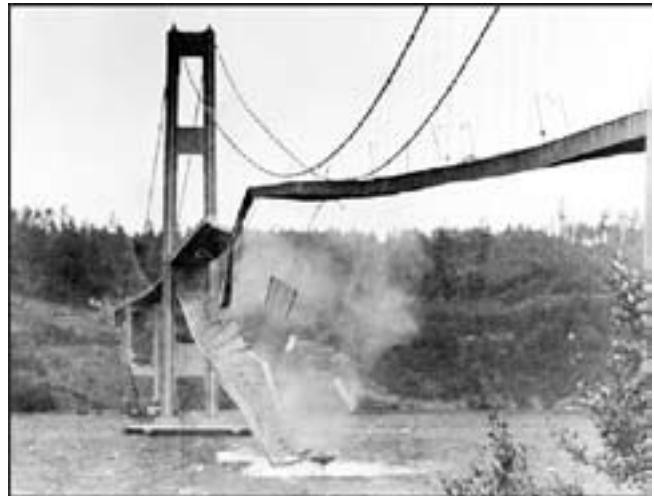
Figure 4. Tacoma Narrows bridge in Tacoma, Washington, 1940

High winds caused the Tacoma Narrows Bridge (nicknamed Galloping Gertie) to sway, undulate and finally collapse under the strain on November 7, 1940. No one was injured in the collapse. The final destruction of the bridge was recorded on film by Barney Elliott, owner of a local camera shop. The engineers learned their lesson from studying this film and conducting wind tunnel tests and included some slight modifications to avoid the resonance phenomenon that caused this bridge to fail. The first replacement bridge opened in 1950 and a parallel bridge opened in 2007. It may be interesting to note that a similar lateral vibration (resonant structural response) was noticed in the Millennium foot bridge, London due to the synchronised walking of pedestrians.

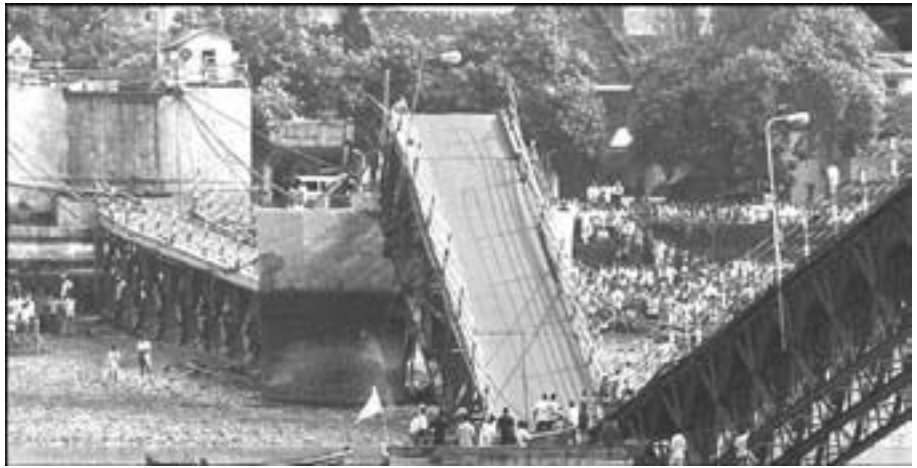
Figure 5. Bridge in Daman, India 2003

The concrete bridge in the western coastal area of Daman, about 120 miles north of Mumbai, India, collapsed, sending a school van, two rickshaws and motorcycles plunging into the muddy river. At least 25 people, including 23 children, died. After the public outrage that followed, the bridge was rebuilt by the National Building Construction Corporation, a government body, at a cost of more than Rs. 10 crore. Barely one and a half

months after its construction, the bridge collapsed again in August 2004 due to heavy floods!

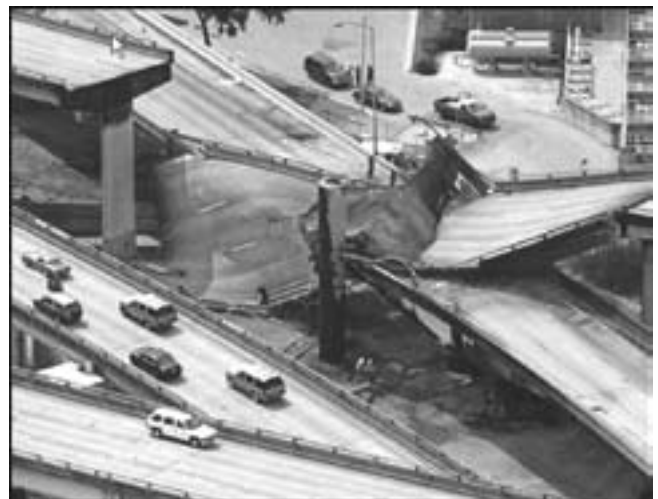
The San Francisco - Oakland bay bridge in Oakland, California, 2007

Figure 6. The San Francisco - Oakland Bay Bridge in Oakland, California, 2007

The San Francisco - Oakland bay bridge collapsed onto another highway ramp in Oakland, California, April 29, 2007, after a gasoline tanker truck overturned and caught fire.

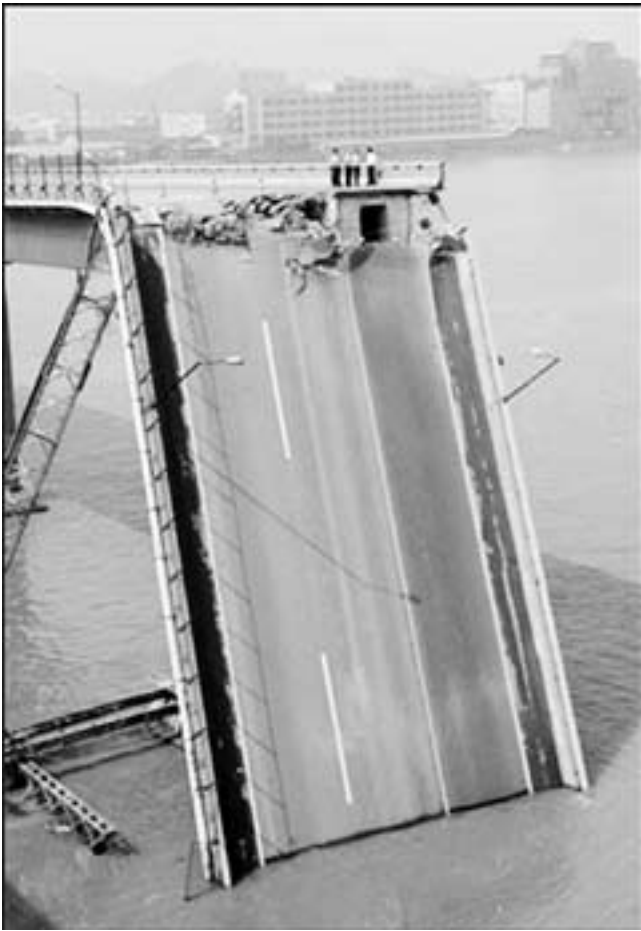
Figure 7. Jiujiang bridge in Foshan, China, 2007

A boat hit the Jiujiang bridge in Foshan, in south China's Guangdong province, collapsing a 200 m section of the bridge and sending nine people into the Xijiang river on June 15, 2007.

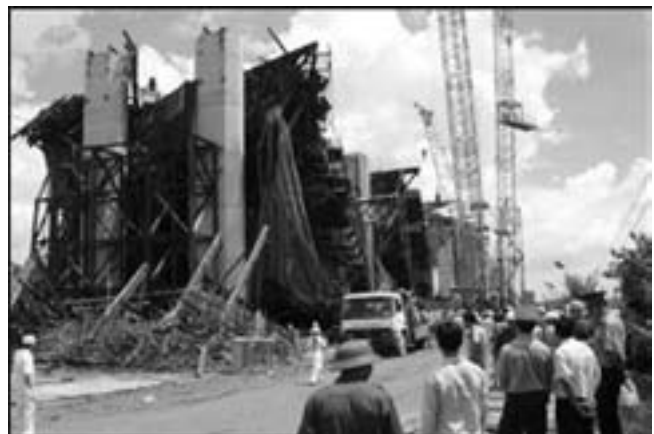
A section of a bridge under construction in southern Vietnam collapsed on September, 26, 2007, killing at least 52 workers and injuring 97 others. The 1.7 mile bridge was started in 2004 and was expected to be finished in 2008. It was to be the largest suspension bridge in Vietnam. The bridge was being built across the Hau river, a branch of the Mekong River, in the southern city of Can Tho. It is part of a heavily used route linking the Mekong delta and Ho Chi Minh city. The collapsed section was more than 98 feet tall and was situated above land on the river bank in Vinh Long province. Concrete had been poured into the collapsed section just one day earlier. The bracing supporting it had apparently weakened and gave way.

Figure 8. Bridge in South Vietnam, 2007
