Some problems of foundation construction for second Thane Creek bridge

S. K. Bhugra and S. R. Nandargikar

Construction of open foundation for the second Thane Creek bridge was indeed a challenging task. Some major problems were encountered during the construction of foundations for pier No. P22 and P19 of this bridge. The paper describes these problems briefly and also highlights how they are resolved.

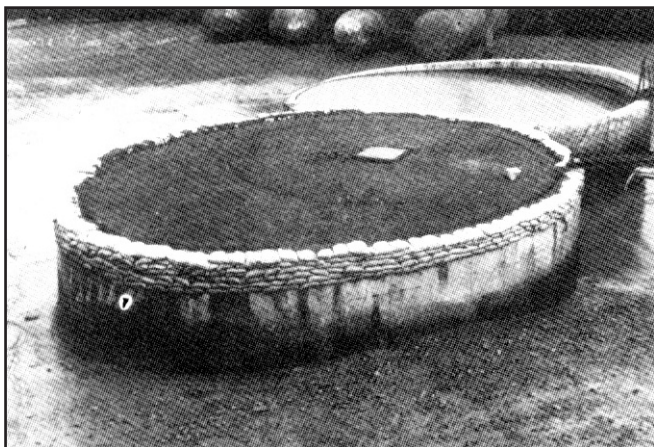
When the cofferdams were sunk to a depth of about 9m, an attempt was made to de water the south cofferdam to facilitate further sinking. It was found that the inner ring beam (7th from top) of the cofferdam had cracked on north and south sides, and the cofferdam had been distorted. The diameter at the top had increased in east-west direction. When checked at bottom, the diameter was also found to have increased in north-south direction. The cofferdam was thus badly deformed.

Vertical cracks, as wide as 15 mm to 20 mm, were also observed on east and south-west locations near the top of the north cofferdam. The second inner beam from top was damaged. A number of diagonal cracks on the surface of the north cofferdam were also observed.

Figure 1. Deformed and cracked cofferdam of pier P22 filled with sand. This island of sand was used for sinking well foundation

Both the concrete cofferdams were badly deformed and cracked.

The consultant ultimately changed the scheme of open foundation for pier P22 and adopted the well foundation.

Both the cofferdams were filled up with stone dust and were used as an island for well foundation, Figure 1. Wells of maximum 8-m outer diameter could be accommodated along the alignment in the badly-deformed and shifted cofferdams, Figure 2.

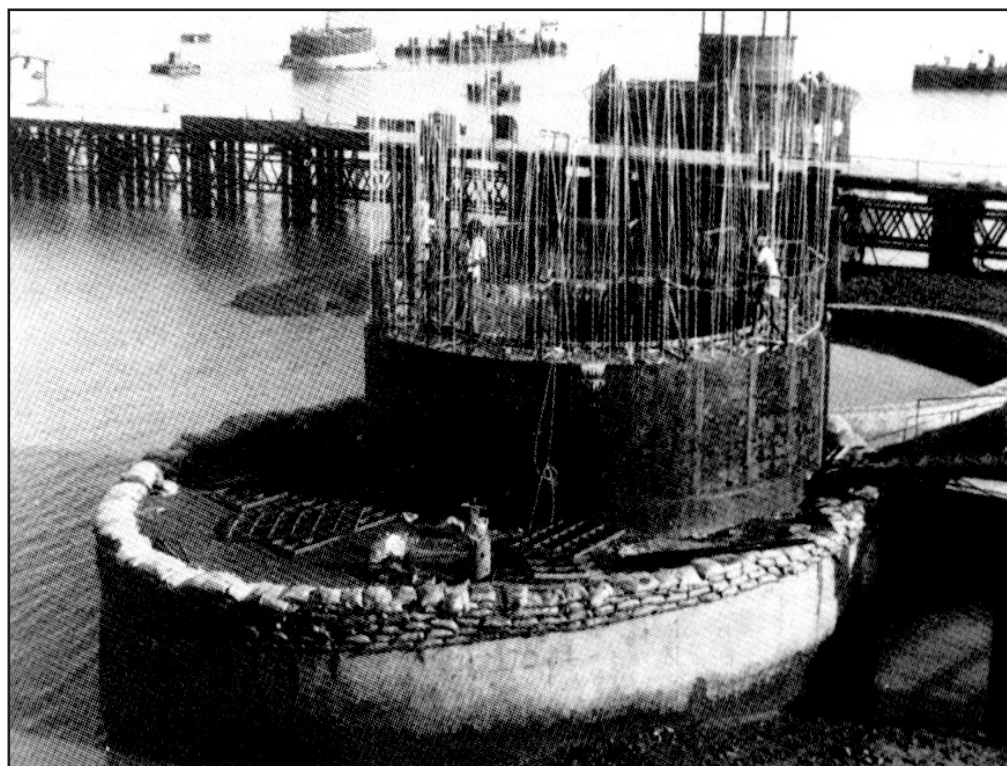
Due to the proximity of the north well with its cofferdam on south-west side, the cutting edge of the well got stuck over concrete ring of the cofferdam and got tilted towards northeast. It was rectified by providing 2 props of 300 x 300 mm

Figure 2. Cracked and deformed cofferdam for pier P22 filled with sand and stone dust. Well steining is also cast to a certain height. Tilt and shift of the cofferdam can be seen from the eccentricity of the placement of well

H-piles to the well from the opposite side and resting against the ring beam of the cofferdam. Kenteledge was also provided on the south-west side. Water jetting in the annular space on south-west side was also attempted to reduce friction. At one time, the contractor fixed 32-mm diameter wire rope around the well, and tied it to pulleys. These pulleys were, in turn, fixed to a winch by 32-mm diameter wire rope to hold back the north well from tilting. Further sinking by cutting rock with jack hammer was continued. Once the well penetrated in the rock strata, it was possible to dewater the well and work in open. Further sinking the well upto the required depth in the rock then became easy. 4.5m socketing of well was provided in the rock, Figure 3. As per the design requirement, 4.5-m deep socketing of the well in the rock was essential since diameter of wells was restricted to only 8 m.

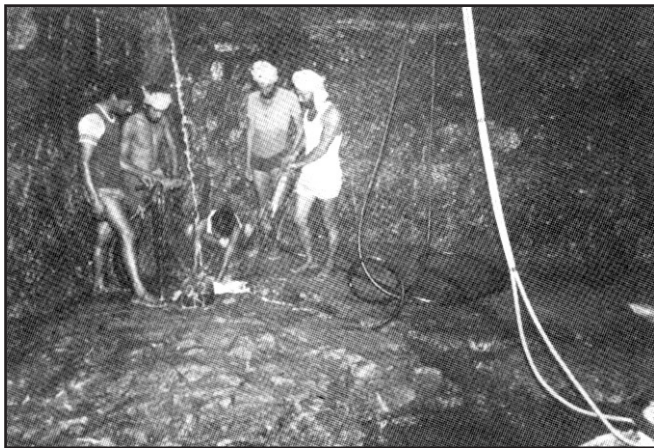
Figure 3. Rock excavation for socketing of well for pier P22 in progress
