# Infrared thermography and its applications in civil engineering

D.S. Prakash Rao

Infrared thermography is a powerful tool to investigate structural condition and equally useful for damage assessment. It is a non-contact and non-destructive method that enables rapid investigations. Highly efficient infrared cameras and versatile software have simplified thermography considerably over the years. While infrared thermography has wide applications in process industries, it is not yet extensively adopted in the investigation of buildings. The paper presents a brief historical account of infrared thermography, the phenomenon of electromagnetic radiation, thermal imaging and applications in civil engineering. Numerous other applications of thermal imaging are also discussed briefly along with the advantages and limitations.

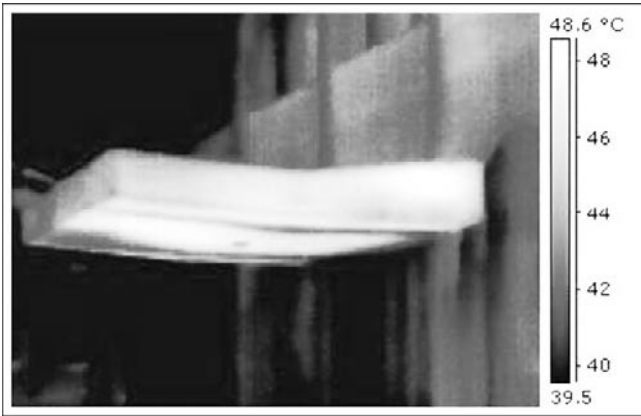
Figure 3. Moisture penetration in a canopy

Figure 3 indicates the thermal image of a canopy. The image was taken late in the evening on a hot summer day in May. Most of the structure is at a high temperature of about 47°C due to the absorption of solar radiation, but for two bands of about 43°C on the soffit. On closer examination, it was found that the structure has a brick lining on the three free sides and rainwater stagnated along the two bands. Subsequently, dust and muck got

deposited along the bands, providing some degree of insulation leading to lower temperatures. Further, the soffit along the bands sounded hollow when struck by a small hammer indicating delamination of plaster and possibly of concrete. The temperature differences caused by the muck deposited and delamination manifested in the form of dark bands.

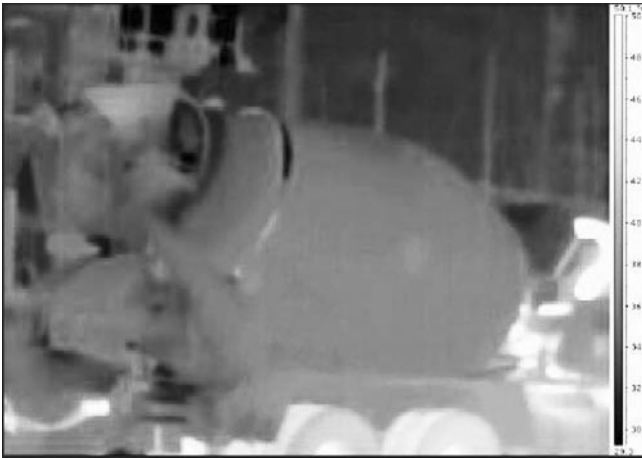
Thermal images help determine the state of fresh as well as hardened concrete<sup>4</sup>. Figure 8 is the thermal image of a ready mix concrete truck delivering at a site on a hot summer afternoon. The tyres of the truck are at about  $46^{\circ}\text{C}$ , and the pump at a temperature over  $50^{\circ}\text{C}$ , while the drum is at about  $38^{\circ}\text{C}$ . The uniform colour of the drum, with no patches of variation, indicates good mixing and concrete of uniform quality. Figure 9 shows

Figure 8. Ready mix concrete delivery truck

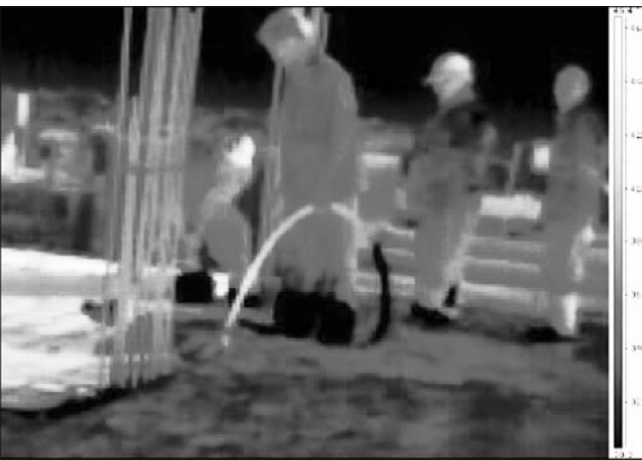
Figure 10. Hot weather concreting

The thermal image of concreting of a slab is shown in Figure 10. The concrete was cast on a hot day with temperature of about 40°C. The concrete poured is cooler than the forms as can be seen from the colour pattern. The forms are at temperatures of about 40 – 44°C due to exposure to direct sun, while the concrete is cooler at 32 – 34°C due to evaporation. The reinforcement bars of the column in the image are at about 38°C. A person with a needle vibrator can also be seen in the image.
