Effect of excessive cement in prestressed concrete girder

C.V. Kand, T.P. Thite and S.M. Litake

DETAILS OF FLYOVER AND METHOD OF CONSTRUCTION

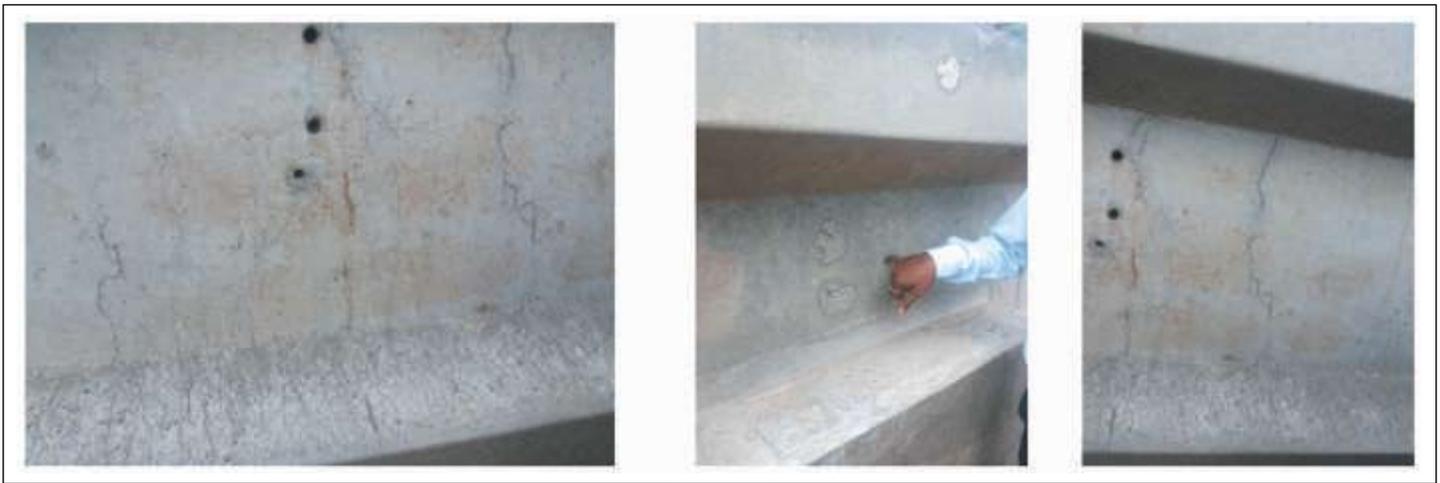
Figure 2. Cracks in girder

One of the stacked girders was critically examined before towing and launching. Distresses were noticed in one girder (Figure 2). There were inclined cracks in the girder indicating either shear deficiency, shrinkage cracks or bad concrete. The surfaces of concrete were rough. This crack could not be ignored; the crack could be due to deficient concrete or deficient design. At the top surface of bottom bulb of girder, pockets due to air bubbles were seen. This could be due to trapped air.

The maximum deflection was 26.19 mm against a theoretical deflection of 26.74 mm. The recovery of deflection was 23.41 mm i.e. 89% which is more than 85% prescribed for deflection test of pre-stressed girders. This recovery showed that the prestressed concrete girder had behaved very well, this high recovery also indicated more than adequate flexibility in the structure; this also showed that the surface cracks were not due to any design deficiency. These appeared to be perhaps due to extra cement provided in this structure.

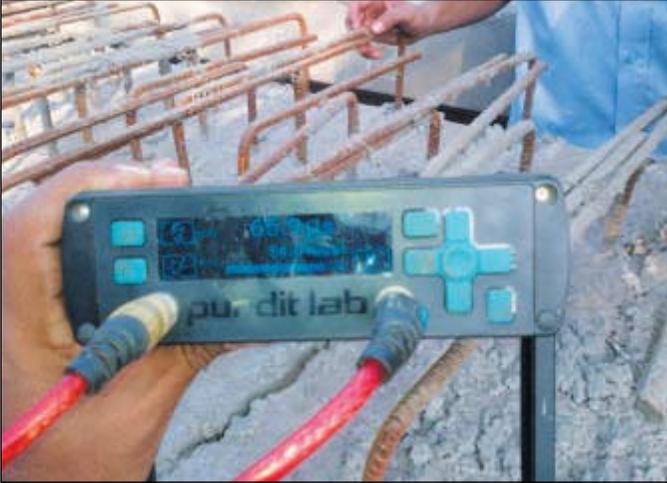
Figure 8. Combination of ultrasonic & rebound hammer test showing girder concrete strength as 54.0 N/mm²

The test has proved that the strength of concrete is not reduced and which was the earlier fear.
