Case study of the repair of a major bridge and some thoughts on repair materials

The paper discusses repair and rehabilitation of a major road overbridge connecting eastern and western suburbs of Andheri, in Mumbai. While the case study is described, the author dwells upon some of the important aspects involved in the selection of appropriate materials and methodologies of repair/rehabilitation.

Salient features of the bridge

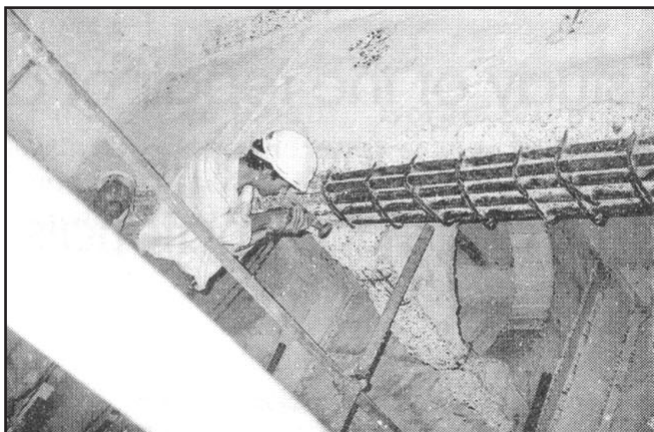
Figure 1. Cleaning corroded bars by mechanical wire-brush

2. Expose the member by means of chisel and hammer. Remove the loose concrete beyond the reinforcement.
3. Remove loose rust from reinforcement by means of tacha and wire brush (mechanical/manually). Apply phosphate-based rust converter capable of removing corrosion products to the reinforcement by brush or cotton waste. After 24 hours wash the reinforcement by clean water jet.

The next important step was to ensure that the corrosion products on the steel are removed effectively. For this, it is reported that the mechanical means prove quite inadequate. Hence, it was correct to use the chemical rust remover-converter material. The application of this material does not reduce the section of steel (like in sand blasting) after having removed the loose oxidation scales. It, in fact, consolidates the left over section. This treatment also helps in

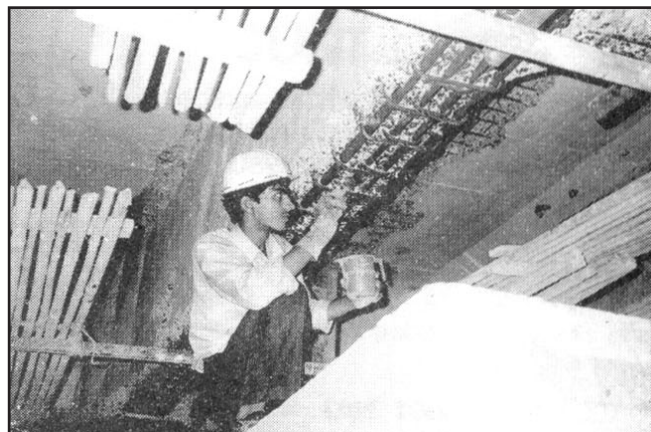
Figure 2. Application of protective coating on steel

4. Providing and applying slurry of 1 part of specially formulated alkaline acrylic-based polymeric solution with 1 to 1.5 part of fresh cement and mix the solution by means of stirrer and apply it on the reinforcement by paint brush. This will act as protective coating on the reinforcement. After 24 hours apply similar second coat of such slurry. Make sure no area is left uncovered.

In order to overcome the above mentioned shortcomings, a slurry of water-based polymer emulsions and cement is applied on steel. This mixture being highly alkaline in nature keeps the environment around steel in a alkaline state. This situation helps greatly in maintaining a passive, Fe_2O_3 film on the steel, thereby preventing corrosion⁷. Besides, this film

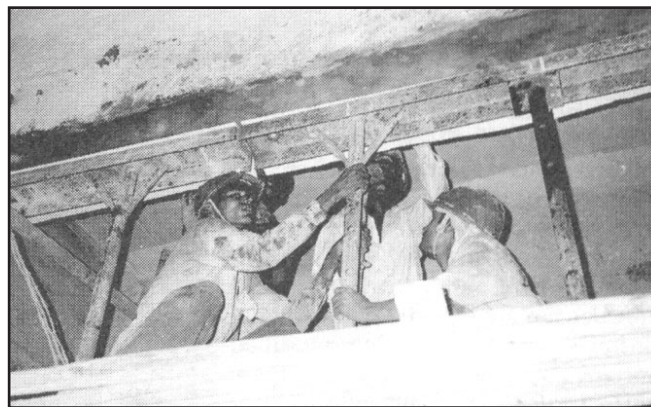
Figure 4. Propping the repaired beam

1. Support the RC members by steel preps and spans appropriately, depending upon loading conditions and extent of damage of the members to be repaired.
