## Why are Open-Ground Storey Buildings Vulnerable in Earthquakes?

Authored by:

C.V.R.Murty

Indian Institute of Technology Kanpur

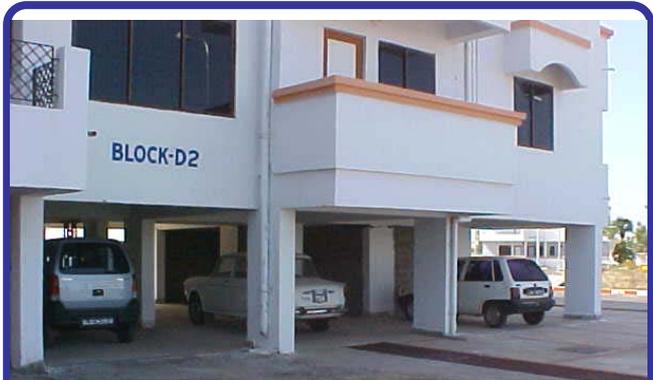
**Figure 1: Ground storeys of reinforced concrete buildings are left open to facilitate parking – this is common in urban areas in India.**

Reinforced concrete (RC) frame buildings are becoming increasingly common in urban India. Many such buildings constructed in recent times have a special feature – the ground storey is left *open* for the purpose of parking (Figure 1), *i.e.*, columns in the ground storey do not have any partition walls (of either masonry or RC) between them. Such buildings are often called *open ground storey buildings* or *buildings on stilts*.

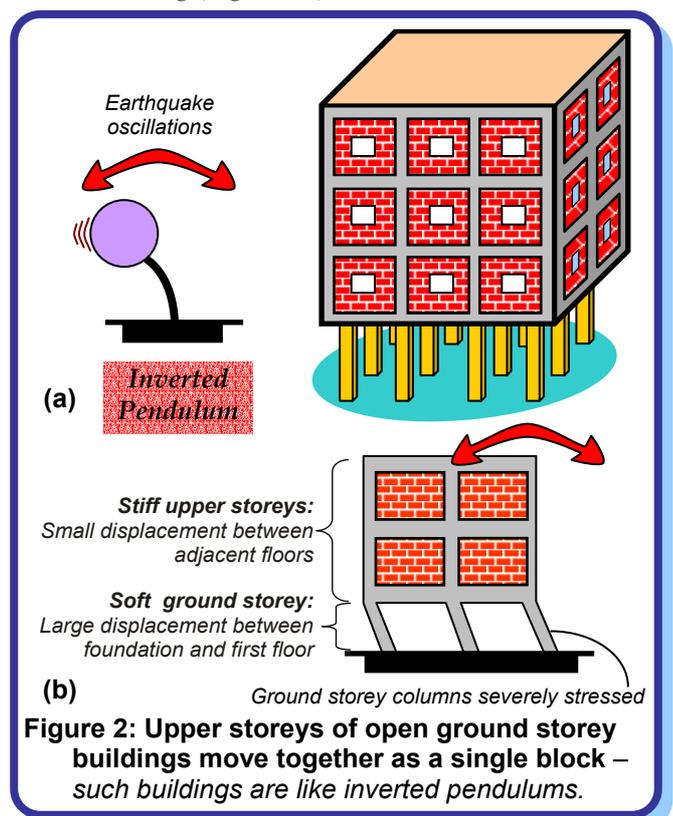
The presence of walls in upper storeys makes them much stiffer than the open ground storey. Thus, the upper storeys move almost together as a single block, and most of the horizontal displacement of the building occurs in the soft ground storey itself. In common language, this type of buildings can be explained as a building on chopsticks. Thus, such buildings swing *back-and-forth* like *inverted pendulums* during earthquake shaking (Figure 2a), and the columns in the open ground storey are severely stressed (Figure 2b). If the columns are weak (do not have the required strength to resist these high stresses) or if they do not have adequate ductility (See IIT-BMTPC Earthquake Tip 9), they may be severely damaged (Figure 3a) which may even lead to collapse of the building (Figure 3b).

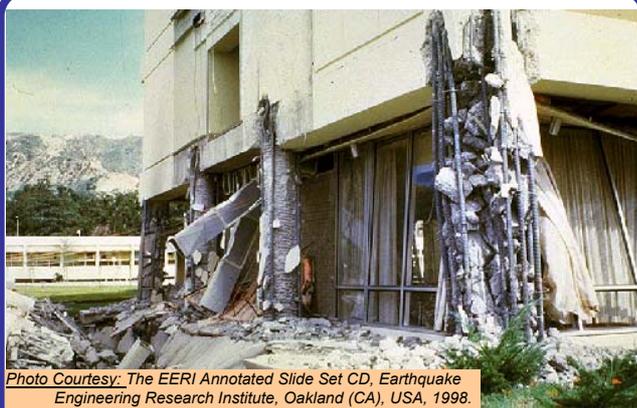
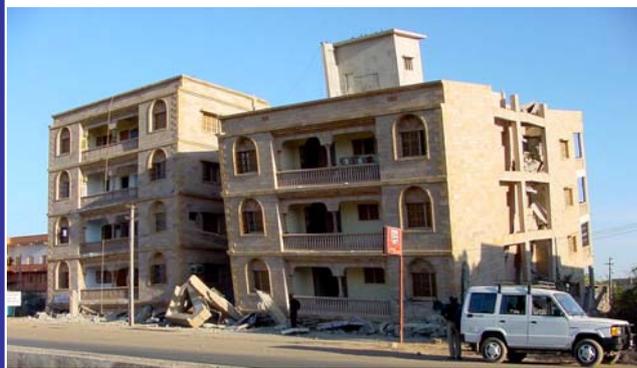
(a) 1971 San Fernando Earthquake

(b) 2001 Bhuj Earthquake

Figure 3: Consequences of open ground storeys in RC frame buildings – severe damage to ground storey columns and building collapses.

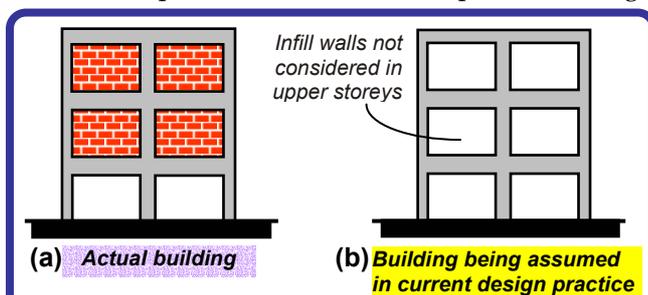
Open ground storey buildings are *inherently poor* systems with sudden drop in stiffness and strength in the ground storey. In the current practice, *stiff* masonry walls (Figure 4a) are neglected and only *bare frames* are considered in design calculations (Figure 4b). Thus, the inverted pendulum effect is not captured in design.

Figure 4: Open ground storey building – assumptions made in current design practice are not consistent with the actual structure.

structure. The Code suggests that the forces in the columns, beams and shear walls (if any) under the action of seismic loads specified in the code, may be obtained by considering the *bare frame* building (without any infills) (Figure 4b). However, beams and columns *in the open ground storey* are required to be designed for 2.5 times the forces obtained from this bare frame analysis.

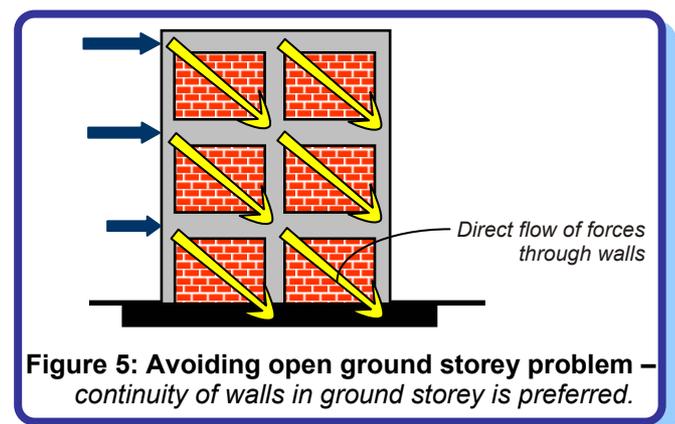
For all *new RC frame buildings*, the best option is to avoid such sudden and large decrease in stiffness and/or strength in any storey; it would be ideal to build walls (either masonry or RC walls) in the ground storey also (Figure 5). Designers can avoid dangerous effects of flexible and weak ground storeys by ensuring that too many walls are not discontinued in the ground storey, *i.e.*, the drop in stiffness and strength in the ground storey level is not abrupt due to the absence of infill walls.

Figure 5: Avoiding open ground storey problem – continuity of walls in ground storey is preferred.
